Effects of Gas Atmosphere and Surface Quality on Rouging of Three Stainless Steels in WFI

Keywords: WFI, rouging, AISI 316L, EN 1.4435, EN 1.4462, EN 1.4539, gas atmosphere, welding, surface finish.

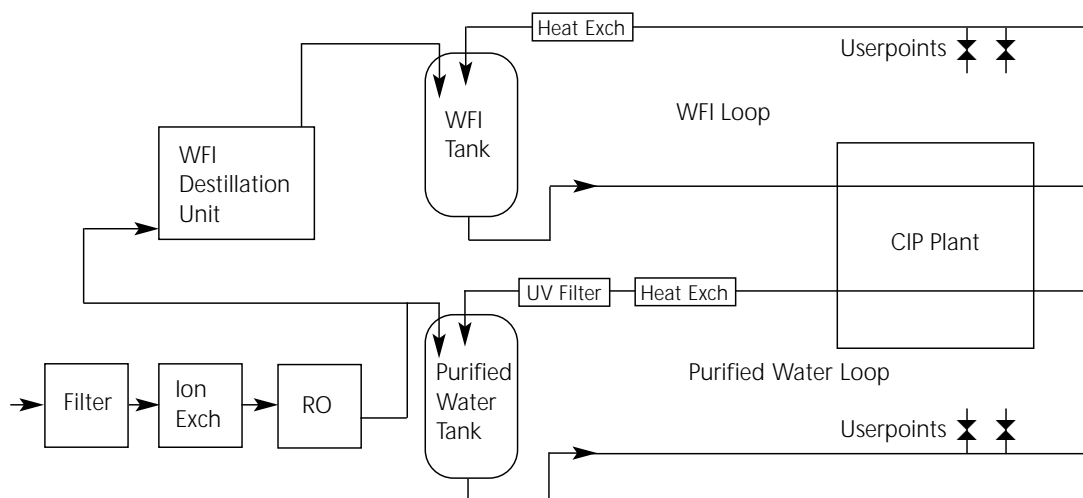
Fig 1. Schematic example as to a WFI plant.

Figure 1 shows a schematic example as to a WFI plant. Figures 2– 4 show examples of rouge experienced in WFI plants

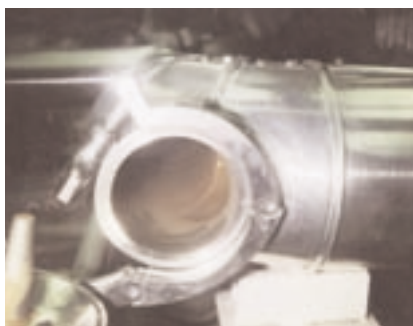
Fig 2. Rouging in a WFI pipe arrangement.

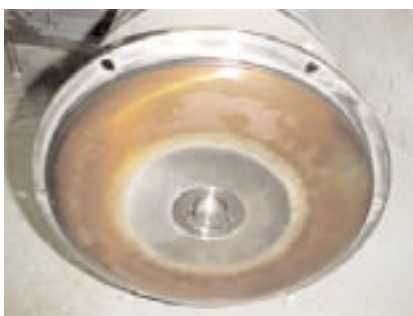
Fig 3. Rouging in a WFI pump.

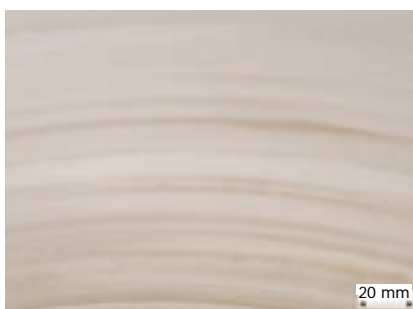
Fig 4. Rouge in a WFI buffer tank. As a result of an alternating water level, rouge has deposited on the shell in circumferential areas of varying height.

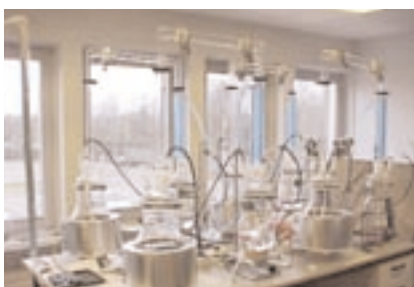
Fig 5. Overview of the test set-up.

The systems were thoroughly purged for three days with the selected gas at a flow of 50 ml/min (mass flow controllers) before turning on the heat. Boiling was then maintained for 6 weeks at constant gas flow of 25 ml/min. Figure 5 shows an overview of the test set-up.

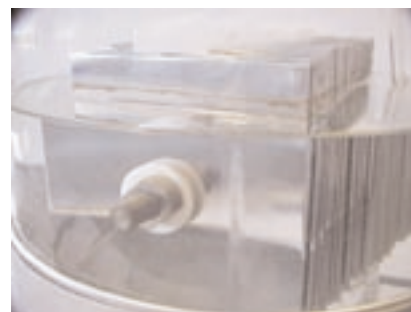
Fig 6. Test cell with a coupon rack showing rouge at the water line after 3 weeks exposure in WFI purged with N₂ (boiling was paused). The coupons include both the #80 and the 2B + ep finish of EN 1.4435 material.

The first signs of rouge became visible after four days of exposure while only little development was observed during the remaining exposure period. In all cases rouge was seen as deposits along the water line of the coupons as shown in Figures 6–7. The most evident rouge formation was seen in the cells purged with N₂ or air with addition of CO₂. The two other atmospheres (air and air minus CO₂) showed less or no rouge formation. This became clear when the coupons and PTFE strips were studied closely after dismantling the cells, see Figure 8. Table 3 summarized the results of the first test series.

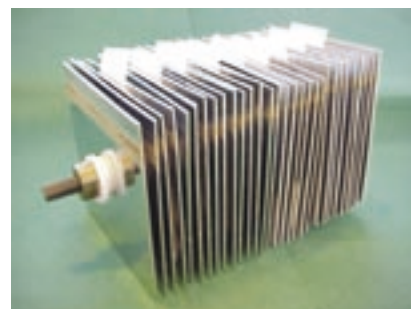
Fig 7. The same coupon rack as shown in Figure 6. The rouge deposits at the water line is very distinct.

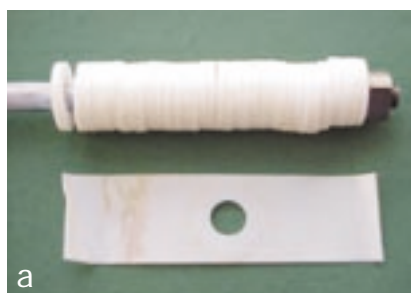
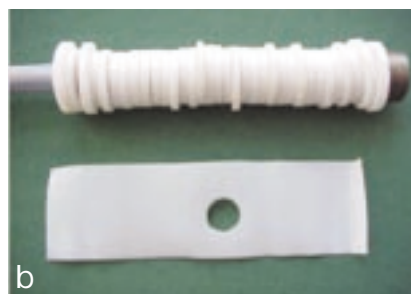
Fig 8. Teflon spacers and strips after exposure of EN 1.4435 in WFI purged with a) Air + 1% CO₂ and b) Air minus CO₂.

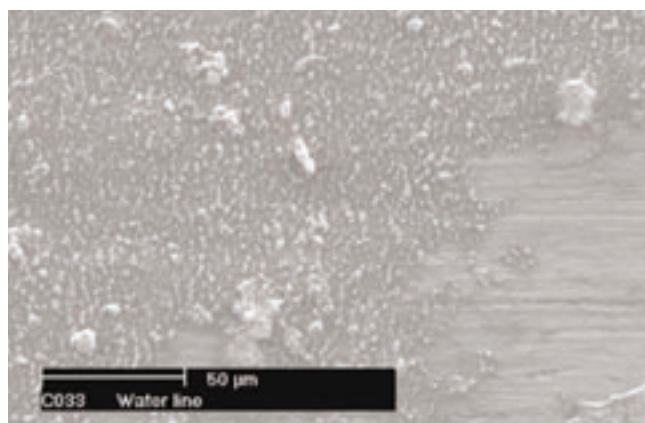
Fig 9. Scanning electron micrograph showing exposed coupon covered by loosely adhered rouge deposits.

change results could not be utilized to evaluate rouge formation. Microscopic investigation of the coupons surface showed that the rouge product consists of relatively loosely adherent particles, see Figure 9. The rouge was evenly distributed on all the investigated strips and coupons. Consequently, the first series of tests did not allow any distinction between the different surface qualities.

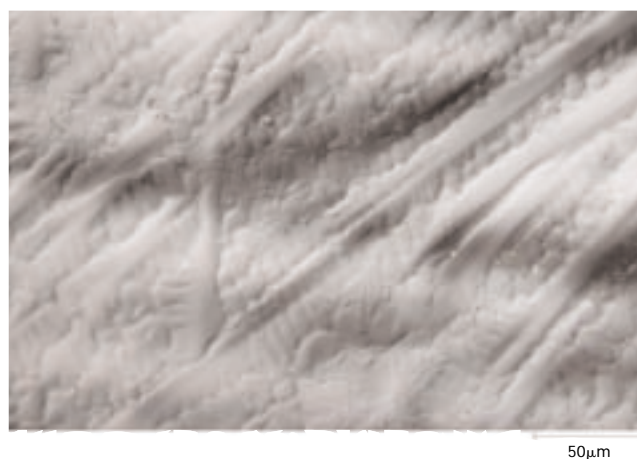
Fig 10. Weld metal of an electropolished EN 1.4435 coupon. The picture was obtained by light microscopy and shows a small amount of δ -ferrite distributed as a skeleton between the primary austenitic phase.

Microscopy investigations of the exposed coupons were undertaken to identify any signs of corrosion. None of the coupons showed obvious indications of corrosion, although the electropolished coupons clearly revealed all forms of imperfections or inhomogeneous structures such as small slag particles or weld areas. The δ -ferrite phase in the welds also appeared clearly on

the electropolished coupons but showed no indications of selective dissolution, see Figure 10. It is more difficult to exclude the possibility of corrosion on the other surfaces since the evaluation was disturbed by either the intergranular etching (2B finish) or grooves (2E finish).

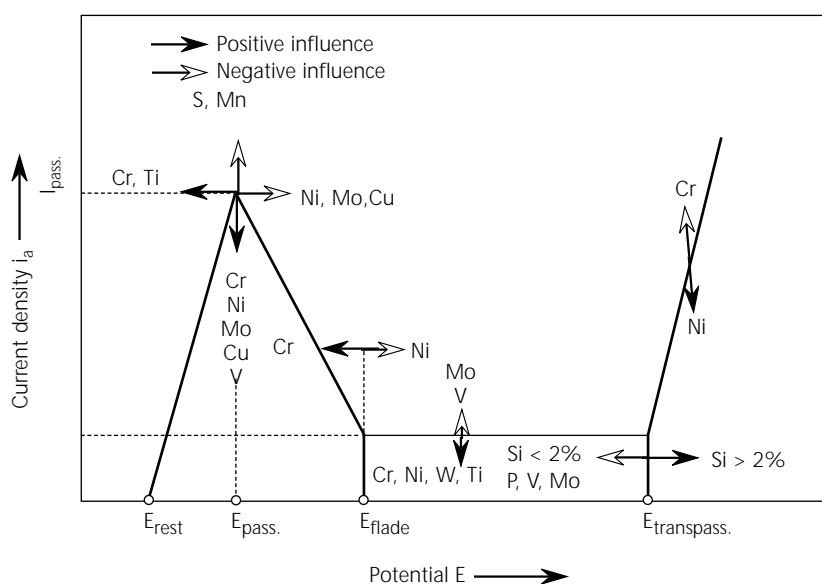
Fig 11. Schematic representation as to the influence of alloy elements on the current density vs. potential curve for stainless steel in acid.

to EN 1.4435. Fundamental work on the passivation of stainless steel in acids shows that an increasing content of molybdenum may increase the passive dissolution rate [17], see Figure 11. However, this fact should only be considered as a possibility, since the boiling WFI is far less aggressive than the acids used to obtain these data.
